BELZONA REPAIRS MASSIVE FAILURE OF KILN SUPPORT CASINGS

Industry: *Cement*
Application: *ENC-Engines and Casings*
Substrate: *Cast Iron*
Products: ** Belzona® 1111 (Super Metal) ,*

Customer Location: *Cement works in Egypt*
Application Date: *March 2004*

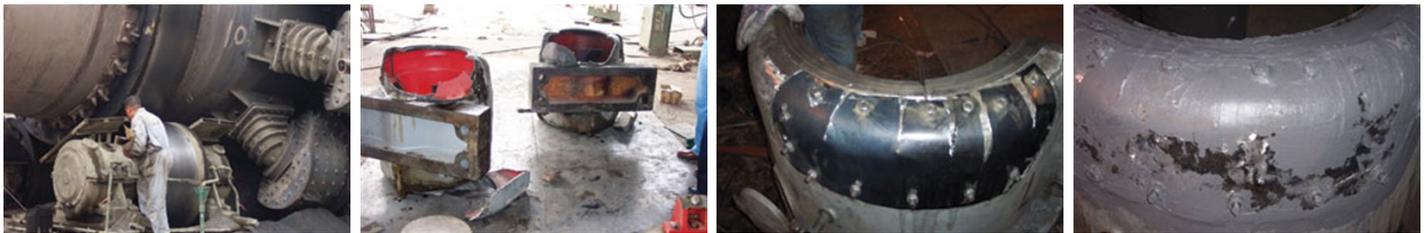
Photograph Descriptions

Casings on trunnion supports shattered due to the breakage of the roller neck.

- * General view of the trunnion supports ,
- * The shattered casings ,
- * One of the fabricated strengthening plates in position ,
- * Belzona® 1111 used to bond and seal the cracked casing ,

Application was carried out in accordance with Belzona Know-How System Leaflet ENC-1.

Various strengthening plates and straps were used to add strength to the repairs. Two large casings were completely restored. Alternative was the replacement at the cost of \$20,000 each and six months delivery time.
