# BELZONA REPAIRS MASSIVE FAILURE OF KILN SUPPORT CASINGS

ID: 447

Industry: *Cement*  
Application: *ENC-Engines and Casings*  
Substrate: *Cast Iron*  
Products: *\* Belzona® 1111 (Super Metal) ,*

Customer Location: *Cement works in Egypt*  
Application Date: *March 2004*

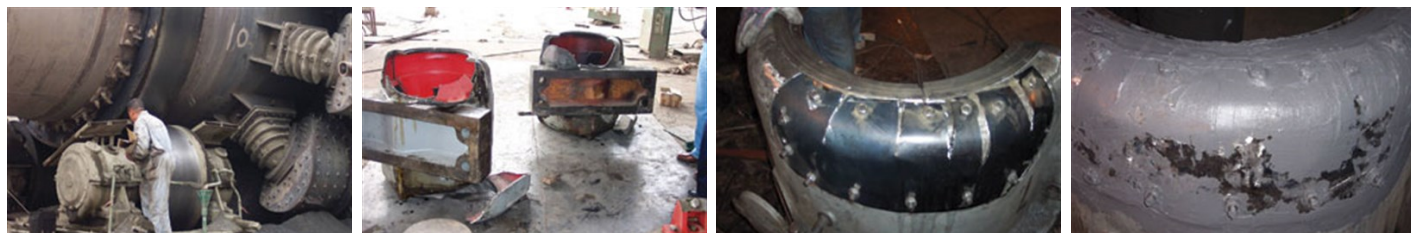
*Casings on trunnion supports shattered due to the breakage of the roller neck.*

- \* General view of the trunnion supports ,
- \* The shattered casings ,
- \* One of the fabricated strengthening plates in position ,
- \* Belzona® 1111 used to bond and seal the cracked casing ,

Application was carried out in accordance with Belzona Know-How System Leaflet ENC-1.

Various strengthening plates and straps were used to add strength to the repairs. Two large casings were completely restored. Alternative was the replacement at the cost of \$20,000 each and six months delivery time.
