# BELZONA REPAIRS CONVEYOR DRIVE SHAFT IN-SITU

ID: 448

Customer Location: *Cement works in Egypt*  
Application Date: *September 2003*

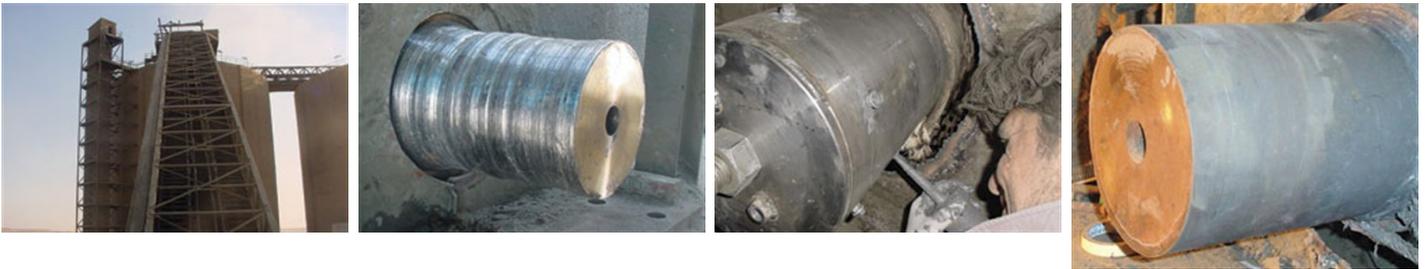
*Drive shaft was badly worn due to incorrect tightening of the adjustable sleeve which leads to relative motion between the shaft and the sleeve.*

- \* General view of the elevator lifting clinker into silos ,
- \* Damage to the shaft ,
- \* Former in place and Belzona® 1311 being injected ,
- \* Accurate diameter restored to the shaft ,

Belzona® 1311 was injected, using pneumatic injection pistol, into former constructed to restore correct shaft diameter. The Belzona repair was carried out without need to remove shaft from the plant saving many days work.
