BELZONA PROTECTION OF MAIN COOLING WATER PUMP

Customer Location: Power station in Egypt
Application Date: July 2003

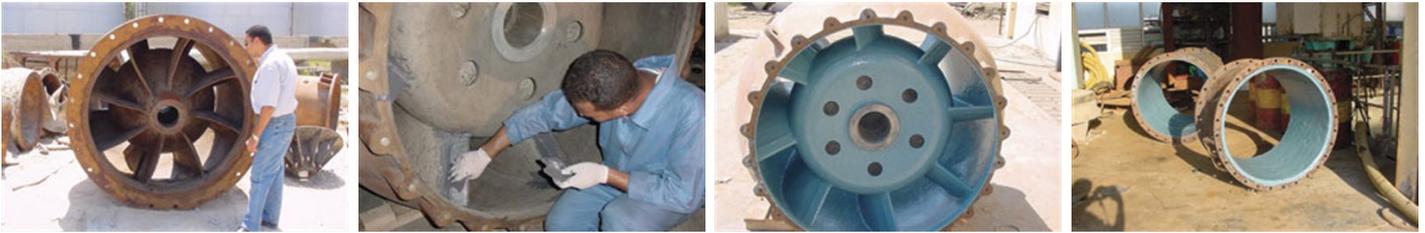
Photograph Descriptions

Severe erosion-corrosion caused by the brackish water being pumped.

- * Part of the pump being inspected ,
- * Rebuilding leading edges of vanes ,
- * & 4. various parts of the pump protected with Belzona® 1341 ,

Application was carried out in accordance with Belzona Know-How System Leaflets CEP-1 and CEP-3.

Long term protection and restoration of efficiency effected to the pump.
