BELZONA EMERGENCY LEAK SEALING: THREE HOURS LATER - IT'S READY

ID: 450

Customer Location: *Fertilizer producer in Egypt*
Application Date: *October 2003*

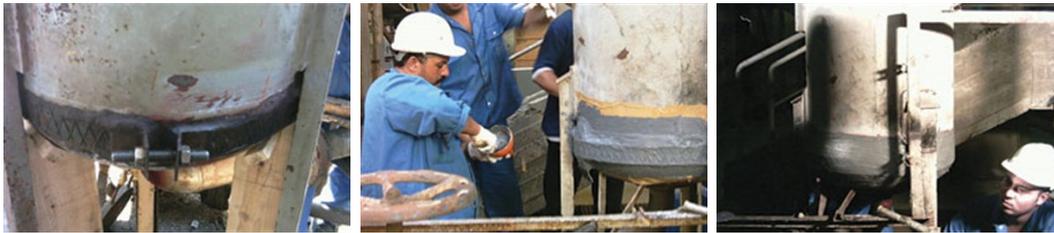
Corrosion of vessel had caused leak.

- * Belzona® 1291 used in conjunction with metal clamp to initially stem the leak ,
- * Belzona® 1111 plus Belzona® 9341 (Reinforcement Tape) applied to strengthen the repair ,
- * Repair completed in 3 hours ,

Belzona® 1291 was initially used in conjunction with a metal clamp to stem the leak before applying Belzona® 1111 with Belzona® 9341 (Reinforcement Tape) to complete the application. Repair completed quickly and safely without heat so preventing the need for a major plant shut-down.
