# REBUILDING TURBINE FLANGE FACES WITH BELZONA

Industry: *Power*  
Application: *ENC-Engines and Casings*  
Substrate: *Steel*  
Products: *\* Belzona® 1311 (Ceramic R-Metal) ,*

Customer Location: *Power station in Egypt*  
Application Date: *May 2004*

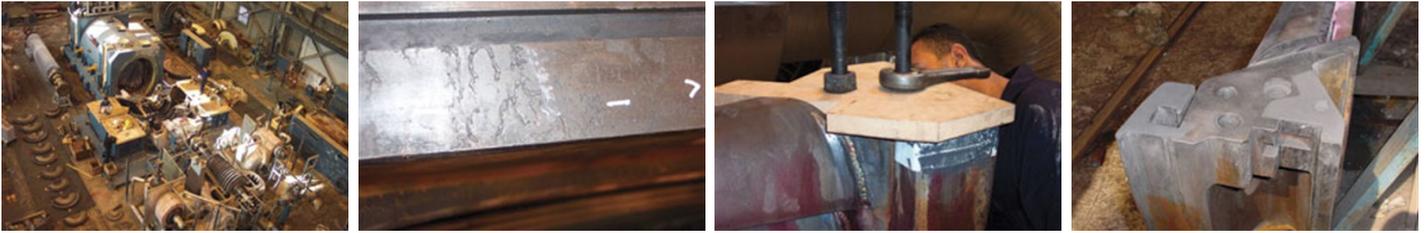
*Corrosion and steam cutting on many areas of flange faces.*

- \* General view of the turbine ,
- \* Typical damage found on the flanges ,
- \* Former clamped in place to form the Belzona® 1311 ,
- \* One of the many repaired areas ,

Formers were cut from MDF (Medium Density Fiber Board) to match the repair areas on the various flange areas. Belzona is a proven effective long term repair for this type of damage.
