# BELZONA REPAIRS TO FERRY MAIN ENGINE

**Customer Location:** Ferry operator in Egypt  
**Application Date:** November 2003

Main diesel engine from ferry

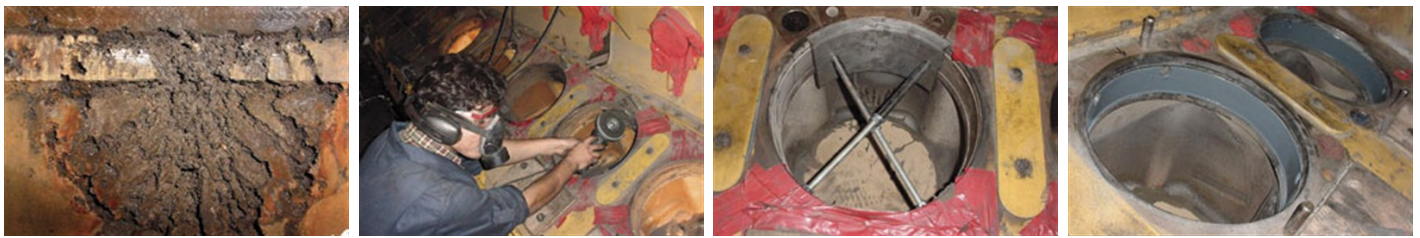
*Severe cavitation and corrosion in cylinder block bores in way of cylinder liner lands.*

- \* The severity of the cavitation clearly evident ,
- \* Surface preparation underway ,
- \* The Belzona® 1311 being formed to profile ,
- \* Completed application with Belzona® 1391 applied to top water gallery ,

Belzona® 1311 used in conjunction with formers to rebuild cavitated areas and restore profiles. Belzona® 1391 applied to coolant galleries. This is a routine repair on engine blocks as cavitation is a common problem in this area of the engine. The Belzona provides a quick effective repair without heat and provides good cavitation and corrosion resistance in the hot coolant.
