# 'ISOLATION' PROBLEMS SOLVED WITH BELZONA

ID: 454

Application: VPF-Valves, Pipes and Fittings

Isolation spools for titanium cooler

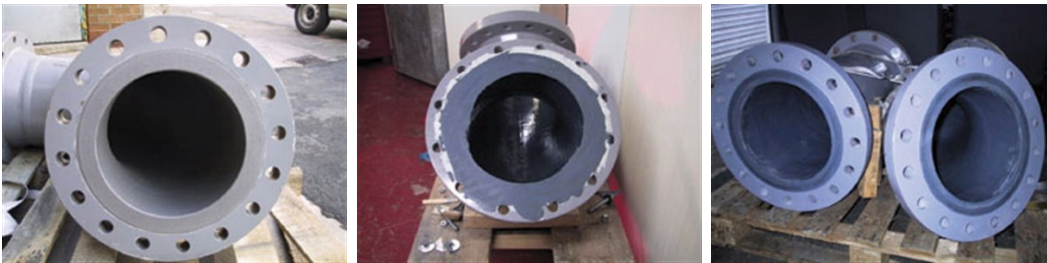
## Photograph Descriptions

- \* Pipespool grit blasted and ready for coating ,
- \* Following coating and removal of the former ready for dressing ,
- \* Post pressure test awaiting despatch to customer ,

Belzona® 1391 and Belzona® 1591 were applied to the internal surface of each of the spools in accordance with Belzona Know-How System Leaflet VPF-2. To eliminate the possibility of defects, which would allow very rapid corrosion, the coating materials were applied as two coat systems. Immediately following application of the second coat, the flange faces were reformed according to Belzona Know-How System Leaflet VPF-13.

A total of four flange pipespools were coated and the flange faces reformed using this process. Subsequent inspection some 12 months later revealed the pipespools to be in perfect condition.
