BELZONA FLANGE REPAIR SYSTEM ELIMINATES BLUSHES ON NEW PROCESS VESSEL

ID: 455

Nozzle flange faces on offshore process vessel due for urgent delivery

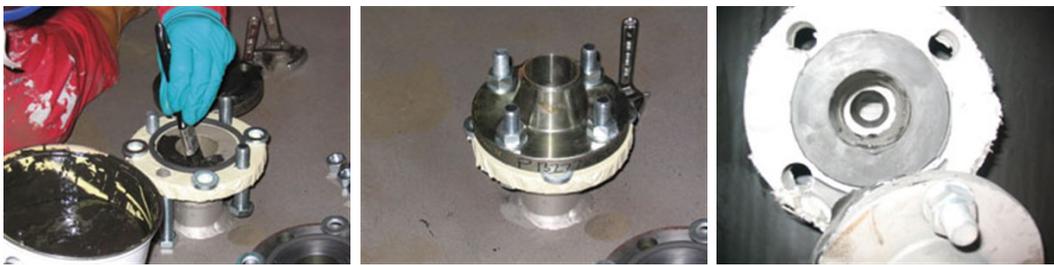
Photograph Descriptions

During surface preparation prior to the installation of a Belzona coating, grit blasting damage had occurred to four internal nozzle flange faces. As a result of this the sand recovery system due to be installed could not be fitted.

- * Application of Belzona® 1591 to flange face ,
- * Completed assembly showing former, bolts and shim ,
- * Finished flange face awaiting removal of masking tape and dressing of internal bore ,

The flange faces were reblasted fully and Belzona® 1591 was installed using a forming process according to Belzona Know-How System Leaflet VPF-13.

Four flange faces were formed using this technique, and were allowed to cure prior to breaking out. Once complete they were protected, the vessel was grit blasted for a second time and Belzona® 1591 applied to the whole vessel. The alternative would have required on-site machining of the flange faces at significant cost.
