# BELZONA FLANGE REPAIR SYSTEM SAVES MONEY

ID: 456

**Customer Location:** Offshore Oil Company - UK North Sea  
**Application Date:** November 2003

Flange faces on 16", 300lb crude oil transfer hoses

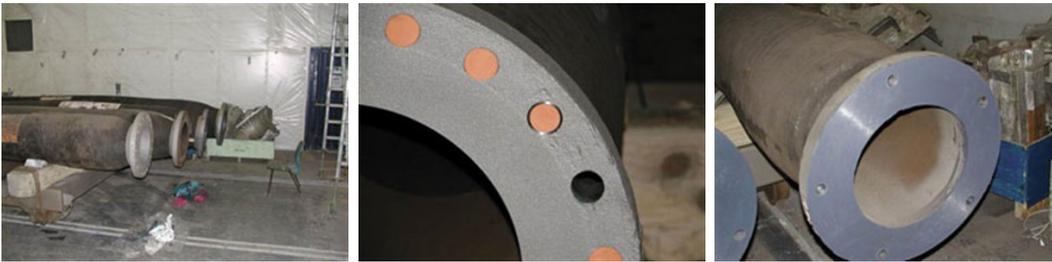
## Photograph Descriptions

External corrosion on the flange faces had resulted in the hoses not being able to seal correctly and as a result were considered no longer fit for purpose.

- \* Four floating hoses awaiting repair ,
- \* Close up showing corrosion damage and plugs and shims fitted into place ,
- \* Completed application, awaiting dressing down and pressure testing ,

A procedure based around Belzona Know-How System leaflet VPF-9 was used to reform the flange faces.

The four hoses shown in the picture represent a cost to the customer if replaced of approximately £100,000 (\$160,000). All four hoses were effectively covered and tested to 18 bar according to International (OCIMF 1991) and Dunlop Oil & Marine Test Guidelines. This was done for a fraction of the cost of replacement hoses.
