# BELZONA FLANGE REPAIR SYSTEM ON OFFSHORE PROCESS VESSEL

ID: 457

Customer Location: Offshore Oil Company - UK North Sea  
Application Date: May 2003

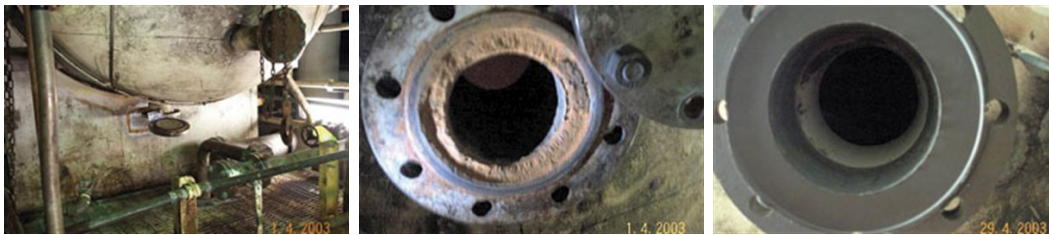
Failure of the glass flake lining material on the flange face had led to severe corrosion on 11 nozzle flange faces.

- \* Offshore degasser vessel ,
- \* Flange prior to refurbishment showing failed glass flake coating ,
- \* Following refurbishment with Belzona® 1111 ,

The flange faces were then reformed using equivalent weldneck flanges in accordance with Belzona Know-How System Leaflet VPF-13.

A total of ten flange faces were reformed, and saved using this Belzona technique. The work was completed over several days without the need for any type of hot work, thus saving the customer significant costs in welding time, quality control as well as eliminating much of the risk associated with hot work offshore.
