# PROCESS VESSEL UPGRADE USING BELZONA ADHESIVE

**Industry:** Oil & Gas  
**Application:** TCC-Tanks and Chemical Containment Areas  
**Substrate:** Coated steel.  
**Products:** \* Belzona® 1111 (Super Metal) Belzona® 1391 (Ceramic HT Metal),  
**Customer Location:** Offshore Oil Company - UK  
**Application Date:** October 2003

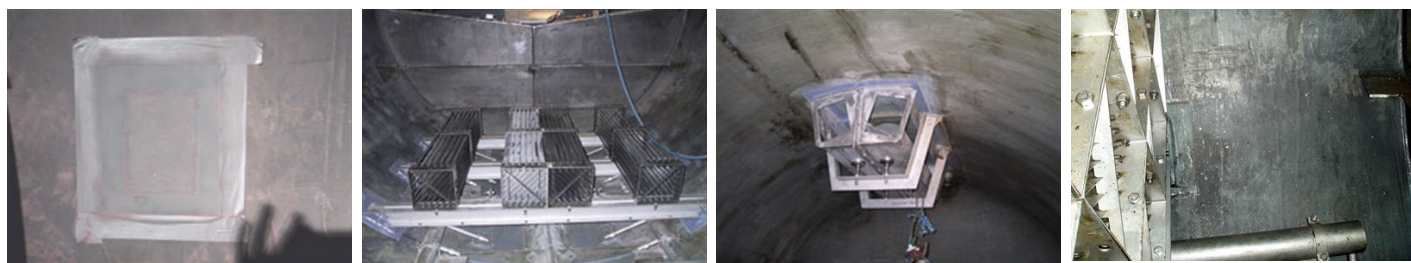
\* Removal of existing coating to allow adhesive to bond directly to steel substrate. Bonding in of mounting clips and overcoating with Belzona® 1391. Sealing of gas demister using Belzona® 1111 and Belzona® 1391. View of application after 8 years in service ,

The original coating was removed in localised areas by blasting. The surrounding coating was cleaned and flash blasted. Once completed, mounting clips were bonded into position using Belzona® 1111. The clips were then coated using Belzona® 1391 which was overlapped onto the surrounding prepared coating in accordance with Belzona Know-How System Leaflet TCC-5.
