BELZONA PROVIDES PROTECTION FOR PRIMARY FAN PUMP

Industry: *Pulp & Paper*
Application: *CEP-Centrifugal Pumps*
Substrate: *Cast iron*
Products: ** Belzona® 1311 (Ceramic R-Metal) ,*
** Belzona® 1341 (Supermetalgilde) ,*

Customer Location: *Papermill in Oregon, U.S.A.*
Application Date: *April 1996*

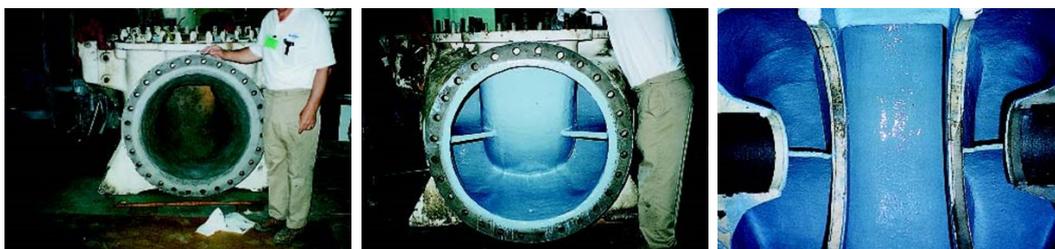
White water chemical attack of this large critical pump caused corrosion pitting of the cast iron pump case, as well as bi-metallic corrosion of the stuffing box.

- * Bottom section of the corroded fan pump ,
- * Final application of Belzona® 1311 to pump case ,
- * Rebuilt fan pump with Belzona® 1311 and Belzona® 1341 ,

The application was carried out in accordance with Belzona Know-How Leaflets CEP-2 and CEP-3.

Consultant was flown from Alabama to Oregon to supervise the application. Corrosion and scale build-up were eliminated and the pump is operating more efficiently to this day.
