# WATERPROOFING CHIME ANGLE WITH BELZONA

Customer Location: Power Plant - Texas USA

Tank Chime Angle

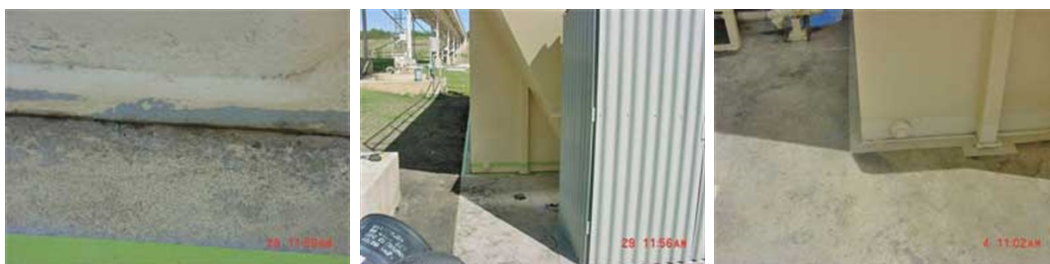
Corrosion was occurring on steel/concrete interface of wastewater tank and pad.

- \* Close look at the problem area ,
- \* Prepared surface taped off ,
- \* Application completed ,

Application was carried out in accordance with a modified version of Belzona Know-How System Leaflet GSS-3.
