BELZONA SAVES CRITICAL EQUIPMENT AT ZINC MINE

Customer Location: Zinc Mine, Namibia

Application: TCC-Tanks and Chemical Containment Areas

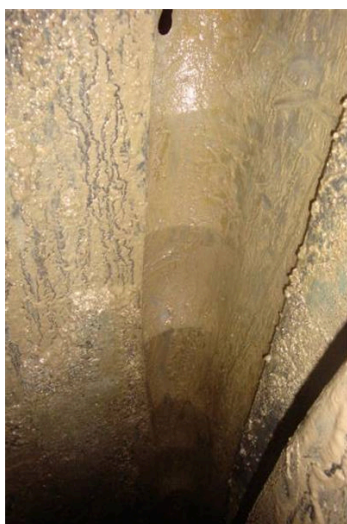
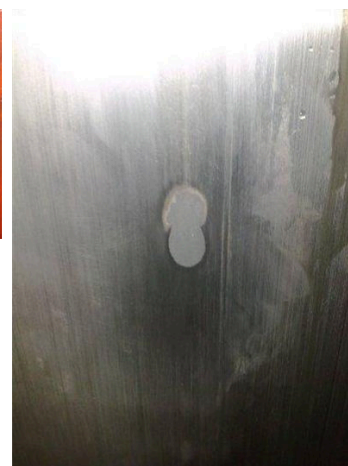
Wear on the riding ring of the primary ore mill resulted in the development of a hole. This allowed leakage of slurry into the mill gearbox lubrication system. As this was a single stream mill, this was a critical piece of equipment and needed to be returned to service immediately.

* Aerial view of the Zinc mine Initial view of the damaged area Damaged area following cleaning Belzona 1111 repair 3 years later

Belzona 1111 Super Metal was applied in accordance with a modified version of Belzona Know-How System Leaflet TCC-5

Belzona 1111 quickly sealed the leaking areas, preventing further contamination and allowed the critical part to return to service faster than conventional repair techniques, saving the customer in downtime and resulting production losses. After three years the repaired area was inspected and is still in perfect condition.
