BELZONA SAVES CRITICAL EQUIPMENT AT ZINC MINE

Customer Location: *Zinc Mine, Namibia*

Application: *TCC-Tanks and Chemical Containment Areas*

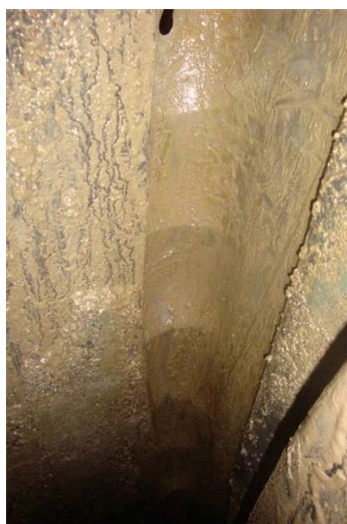
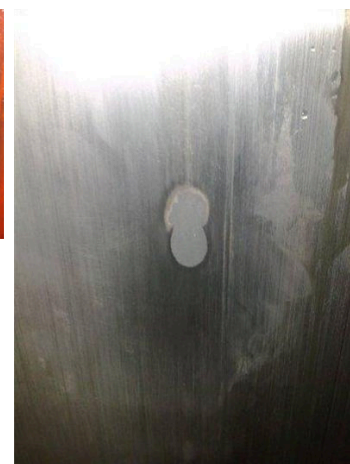
Wear on the riding ring of the primary ore mill resulted in the development of a hole. This allowed leakage of slurry into the mill gearbox lubrication system. As this was a single stream mill, this was a critical piece of equipment and needed to be returned to service immediately.

* Aerial view of the Zinc mine Initial view of the damaged area Damaged area following cleaning Belzona 1111 repair 3 years later

Belzona 1111 Super Metal was applied in accordance with a modified version of Belzona Know-How System Leaflet TCC-5

Belzona 1111 quickly sealed the leaking areas, preventing further contamination and allowed the critical part to return to service faster than conventional repair techniques, saving the customer in downtime and resulting production losses. After three years the repaired area was inspected and is still in perfect condition.
