# BELZONA REPAIRS AND PROTECTS QUENCH TOWER

**Customer Location:** Petro Chemical Complex, Western India  
**Application Date:** 2012

Quench tower suffering Corrosion Under Insulation (CUI).

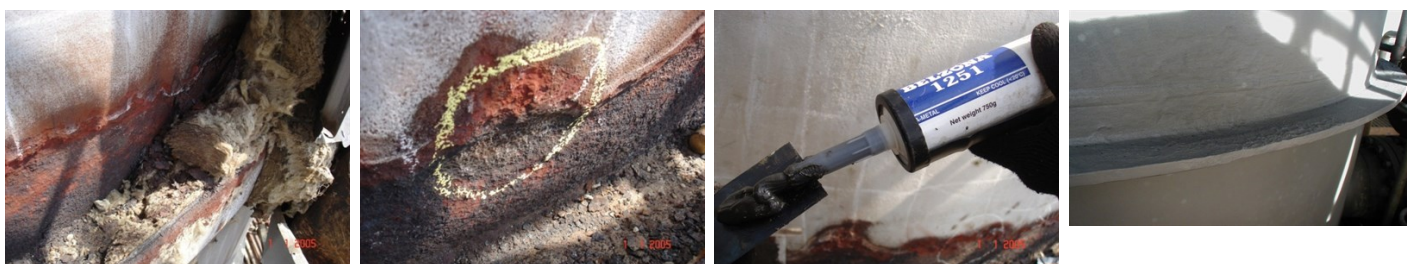
The tall carbon steel tower contains many trays and is insulated to prevent heat loss. Water penetration and condensation had led to severe CUI in many localised areas. The thickness of tower walls had reduced by more than 50% in some areas.

- \* Surface condition behind insulation at 7m height ,
- \* Severe damage due to CUI ,
- \* Application of Belzona® 1251 ,
- \* Completed rebuild with high temperature barrier coating Belzona® 5851 applied to prevent further corrosion ,

Application was carried out in accordance with a modified Belzona Know-How System Leaflet TCC-5. Due to the hazardous area and live tower, scope of surface preparation was limited. Spark free tools were used to remove all loose corrosion back to a sound substrate. Belzona® 1251 was used to repair pitted areas, using doubler plates bonded over the most severely corroded areas. The tower was coated to prevent further corrosion using Belzona® 5851.
