# BELZONA SOLUTIONS FOR LEAKS

ID: 462

Customer Location: Animal food manufacturing - Missouri, USA

Application: VPF-Valves, Pipes and Fittings

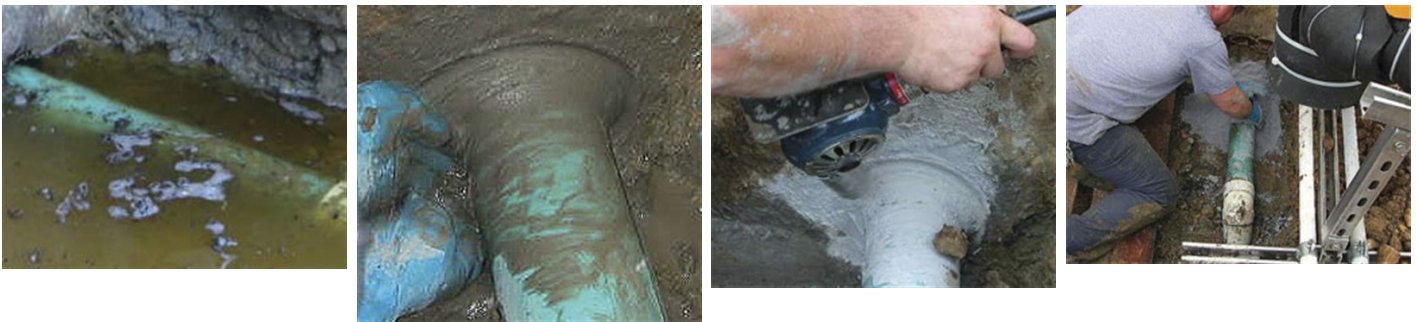
## Photograph Descriptions

Filler used between the drain pipe and the wall when constructed was allowing water to seep through the one inch gap around the pipe and collect underground. A \$10,000 fine from environmental concerns was on the horizon.

- \* Visible leak ,
- \* Leak sealing with Belzona® 4211 in process ,
- \* External heat was applied to decrease curing time and ensure the area was dry ,
- \* Finishing the application ,

The leak was stopped with Belzona® 4211, and then the area was dried with a hot air gun. Belzona® 4111 was used to seal off the leak permanently. This job was done outside during a heavy rainstorm.
