# BELZONA SEALS LEAKING MUSIC ROOM ROOF

ID: 4630

Application: RPA-Roof Problem Areas

Application Date: August, 2012

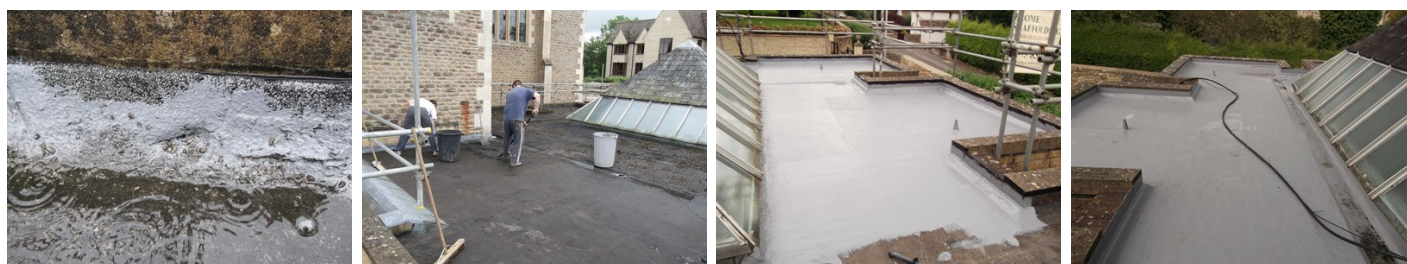
Breakdown of the old bituminous substrate had allowed multiple area's of water ingress causing damage to the fabric of the building & creating health and safety issues. Due to it's location adjoining a listed school building a hot applied system was not acceptable.

- \* Close up of previous repairs which had failed ,
- \* Preparation of the roof by removing loose chippings ,
- \* First coat of Belzona 3131 being applied with reinforcement sheet ,
- \* Completed application several months later ,

The application was carried out in strict accordance with Belzona System leaflet RPA-1.

The Belzona solution being cold curing, combined with its ease of application and ability to seal the various roof details met the clients requirements.
