BOW THRUSTER PROTECTION WITH BELZONA

ID: 4645

Industry: *Marine*
Application: *SOS-Ships and Offshore Structures*

Customer Location: *Dockyard, Montenegro*
Application Date: *November, 2008*

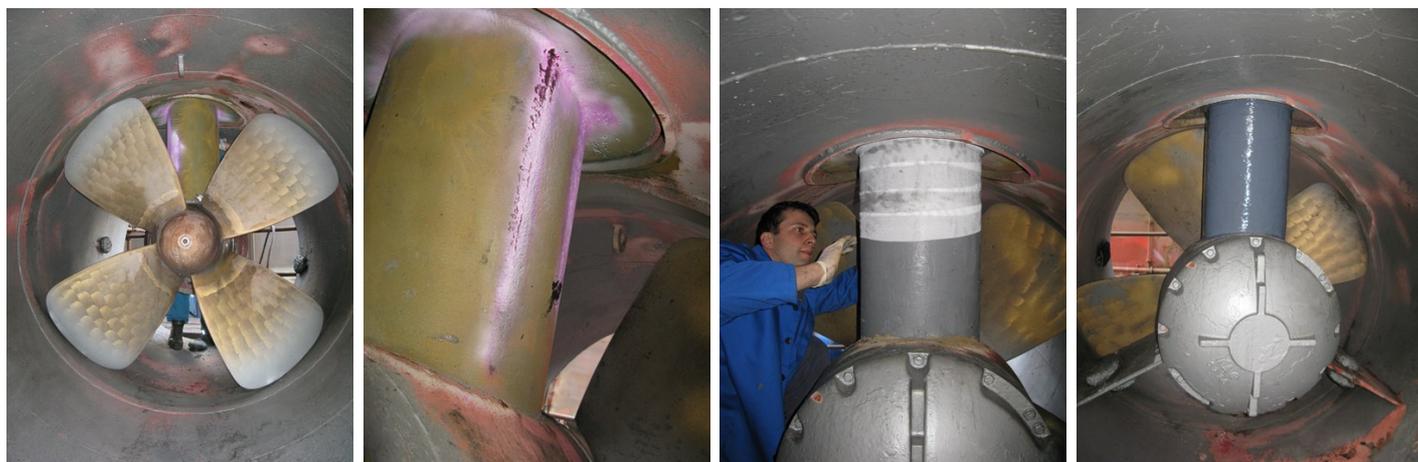
Pitting damage caused by erosion/corrosion to the bow thruster.

- * Bow thruster ,
- * Pitting damage clearly evident ,
- * Reinforcing Tape being combined with Belzona 1311 ,
- * Belzona 1321 protective coating applied to complete the job ,

Application was carried out in accordance with Belzona Know-How System Leaflets SOS-1 and 2.

Belzona's excellent time saving renewal and protection method was a fraction the cost compared to replacement and dry-dock time consuming alternative. Restoration with Belzona was done in 48 hours, resulting in long term erosion/corrosion protection.
