BELZONA SEALS LEAKING CABLE END BUSHING

ID: 4646

Customer Location: Electricity substation, UK
Application Date: MAY 2013

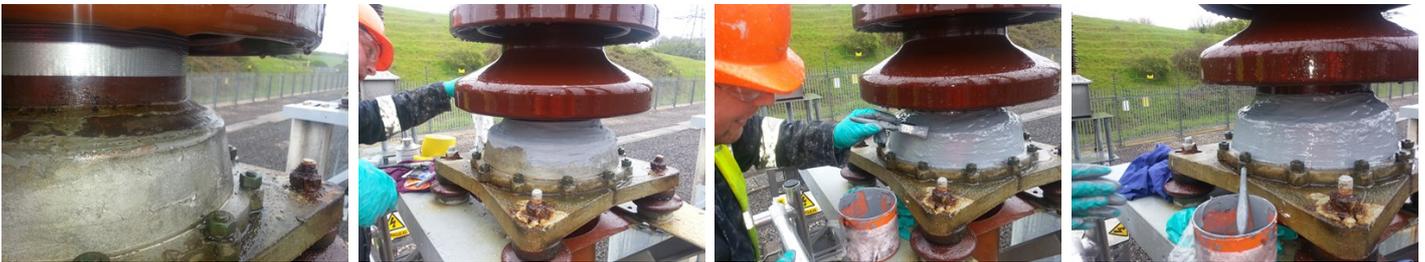
Photograph Descriptions

* Original bushing condition. During the application of Belzona® 1291, Belzona® 1221 & Belzona® 1161. Application of the Belzona® 5831. Completed application. ,

Cement joint between porcelain and steel flange had broken down on bushing - Yellow Phase

The application was carried out in accordance with Belzona system leaflet VPF-11. After cleaning and abrading the substrate Belzona® 1291 & Belzona® 1221 were used to stem the leak before applying Belzona® 1161 with reinforcement tape. Finally Belzona® 5831 was applied to the repair area.
