KITCHEN SAFETY IMPROVED THANKS TO BELZONA

ID: 465

Customer Location: *School in UK*
Application Date: *July 2002*

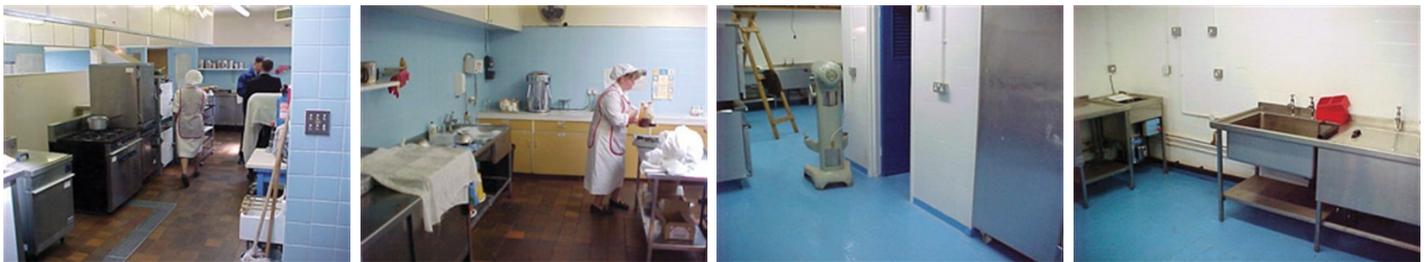
Photograph Descriptions

Routine health inspection had highlighted hygiene and safety problems with the floor area necessitating refurbishment before the school re-opened.

- * Kitchen area prior to the Belzona application ,
- * Wash area prior to the Belzona application ,
- * Belzona® 5231 applied ,
- * Application completed ,

Two coats of Belzona® 5231 were applied after thoroughly cleaning and grit blasting the existing tiled surface.

Belzona® 5231 created a hygienic, seamless floor surface with the right degree of non-slip to provide safe footing for the kitchen staff. The application was completed smoothly in the short holiday period during which the school was closed.
