# INSPECTION PIT SAFETY IMPROVED WITH BELZONA

ID: 466

**Industry:** General Industry  
**Application:** FPA-Floor Problem Areas  
**Substrate:** Concrete  
**Products:** \* Belzona® 5231 (SG Laminate) ,  
\* Belzona® 4411 (Granogrip) ,

**Customer Location:** Military installation - UK  
**Application Date:** July 2002

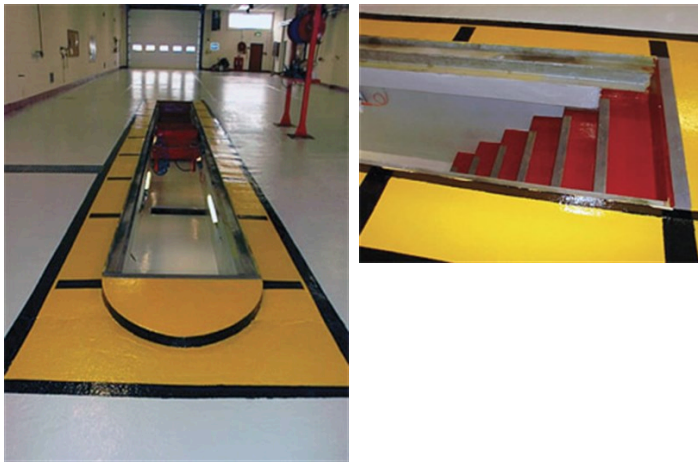
Routine refurbishment of the workshops was being undertaken with particular emphasis on improving safety in and around the inspection pits.

- \* Overview of the inspection pit, following application. ,
- \* Belzona systems improve safety on steps too. ,

After scabbling the concrete and planing rough areas a two-coat system of Belzona® 5231 was applied to the workshop floor and inspection pit. An additional strip of Belzona® 4411 grip system was applied to step nosings to provide additional grip and safety.
