# BELZONA REPAIR TO LOADER TYRE SIDEWALL

ID: 4669

Industry: *Mining & Quarrying*  
Application: *SHM-Solids Handling Machinery*

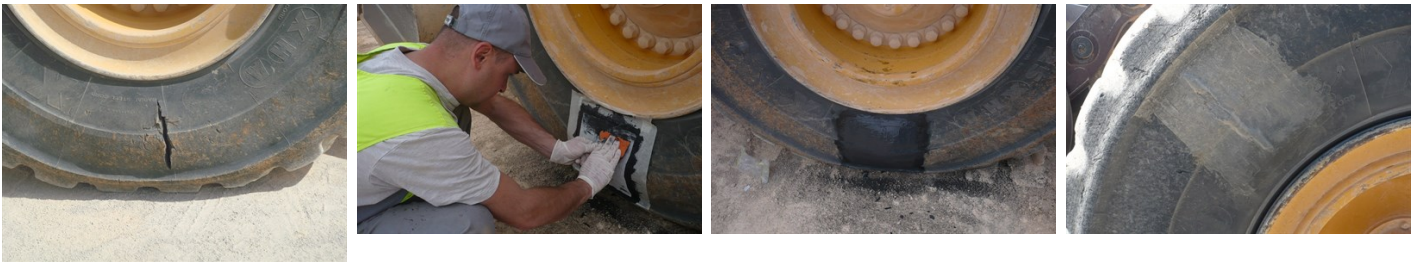
## Photograph Descriptions

*There was a large crack in a tyre, but it was not leaking and the steel reinforcement was still in good shape. Customer needed to keep the loader in operation.*

- \* Damaged tyre on wheel loader ,
- \* Application in progress ,
- \* Application finished ,
- \* Site revisited after 3 months, the tyre is still in perfect shape ,

Application was carried out in accordance with Belzona Know-How System Leaflet SHM-9.

The two alternatives were either to replace the tyre or to dismantle it and transport it to the nearest workshop. Belzona repair was carried out during the weekend and customer didn't lose any production time. The Belzona repair prevented further deterioration of the tyre and was performing well when expected three months later.
