# BELZONA® PROTECTS A MASSIVE THICKENER AT A STEEL MILL

**Industry:**  
**Application:** TCC-Tanks and Chemical Containment Areas  
**Substrate:** Carbon steel  
**Products:** \* Belzona® 1111 (Super Metal) ,  
 \* Belzona® 5891 (HT Immersion Grade) ,

**Customer Location:** Steel Mill, USA  
**Application Date:** 2008

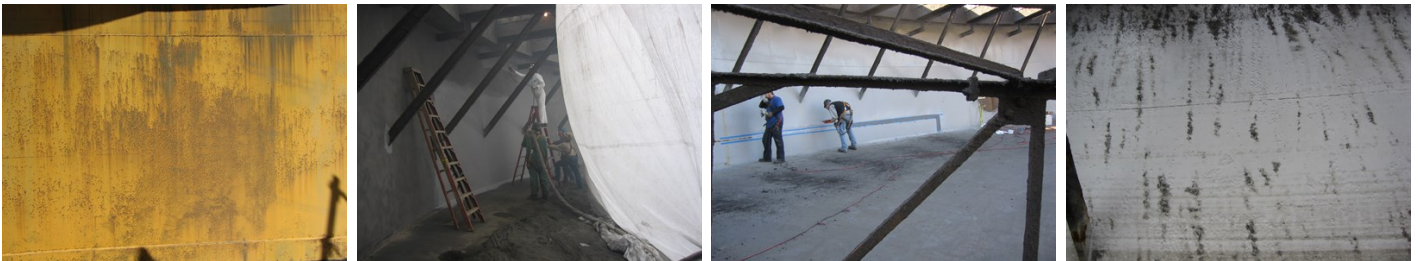
*Thickener suffering from a severe corrosion*

- \* The walls of the thickener suffering from corrosion ,
- \* Application of Belzona 5891 by spray ,
- \* Belzona coating damaged caused by welding work done to the outside of the thickener. The damage was faired with Belzona 1111 and overcoated with Belzona 5891 ,
- \* The walls of the thickener after 1-year inspection ,

Application was carried out in accordance with a modified version of Belzona Know-How System Leaflet TCC-3. Belzona® 5891 was applied using airless spray equipment.

The thickener has been in service for 5 years since the repair with Belzona was done. Both 1-year and 5-year inspections found the equipment in a good condition.
