BELZONA® PROTECTS A MASSIVE THICKENER AT A STEEL MILL

ID: 4671

Thickener at a steel mill

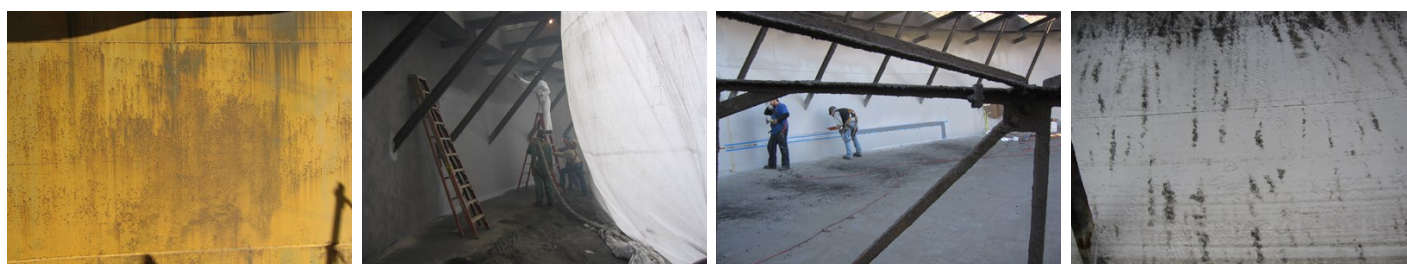
Photograph Descriptions

- * The walls of the thickener suffering from corrosion ,
- * Application of Belzona 5891 by spray ,
- * Belzona coating damaged caused by welding work done to the outside of the thickener. The damage was faired with Belzona 1111 and overcoated with Belzona 5891 ,
- * The walls of the thickener after 1-year inspection ,

Application was carried out in accordance with a modified version of Belzona Know-How System Leaflet TCC-3. Belzona® 5891 was applied using airless spray equipment.

The thickener has been in service for 5 years since the repair with Belzona was done. Both 1-year and 5-year inspections found the equipment in a good condition.
