BELZONA® PROVIDES LONG-TERM PERFORMANCE IN BRIDGE JOINTS

ID: 4672

Joints needed to be sealed between existing armor plates on the bridge

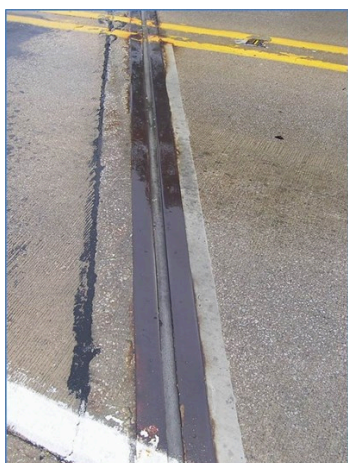
- * Application of Belzona® 4521 between the armor plates ,
- * The intentional pinhole in the bay beneath Belzona application remains unchanged after 5-year service ,
- * The bays on the east end of the bridge beneath Belzona application shows no signs of leakage after 5-year service ,

Application was carried out in accordance with the Belzona Know-How System Leaflet FPA-6 using approximately 200 cu in of Belzona® 4521.

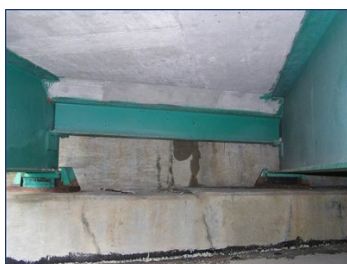
was reviewed and showed no signs of leakage after several hours of hard rain. An intentional pinhole was added during installation to test failure resistance. Pinhole also remained unchanged after 5 years. A conventional silicone joint material installed on the other part of the bridge began leaking within 12 months of being placed.
