BELZONA® PROVIDES LONG-TERM PERFORMANCE IN BRIDGE JOINTS

ID: 4672

Industry: *Buildings & Structures*
 Application: *FPA-Floor Problem Areas*
 Substrate: *Concrete and steel*
 Products: ** Belzona® 4521 (Magma-Flex Fluid) ,*

Customer Location: *Department of Transportation, USA*
 Application Date: *2005*

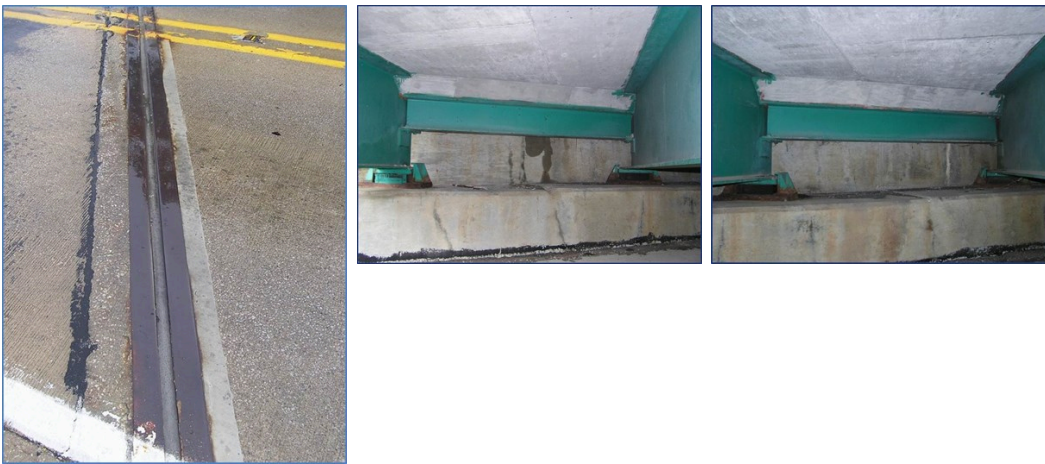
Photograph Descriptions

- * Application of Belzona® 4521 between the armor plates ,
- * The intentional pinhole in the bay beneath Belzona application remains unchanged after 5-year service ,
- * The bays on the east end of the bridge beneath Belzona application shows no signs of leakage after 5-year service ,

Application was carried out in accordance with the Belzona Know-How System Leaflet FPA-6 using approximately 200 cu in of Belzona® 4521.

Belzona solution has a long successful history providing long term performance. After 5 years in service, Belzona® 4521 application

was reviewed and showed no signs of leakage after several hours of hard rain. An intentional pinhole was added during installation to test failure resistance. Pinhole also remained unchanged after 5 years. A conventional silicone joint material installed on the other part of the bridge began leaking within 12 months of being placed.
