# BELZONA INSITU SHAFT REPAIR SOLUTION SAVES DAYS OF LOST PRODUCTION

ID: 4675

Industry: *Mining & Quarrying*  
Application: *MPT-Mechanical Power Transmission*

Customer Location: *Lime stone quarry, SW England*  
Application Date: *August 2013*

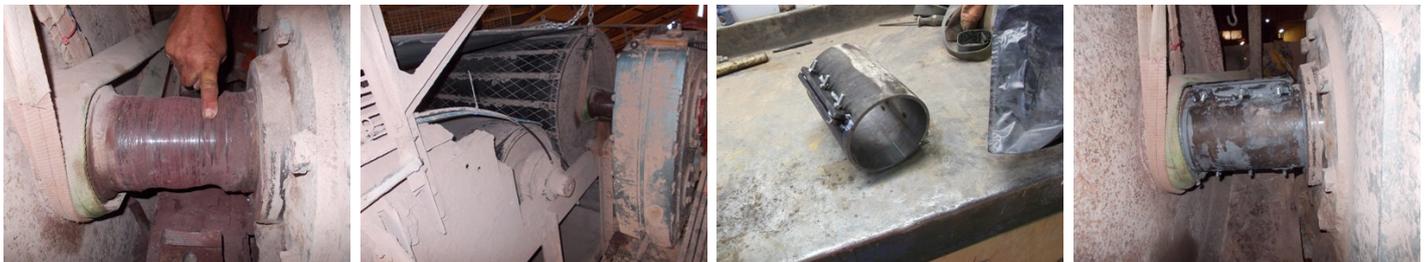
## Photograph Descriptions

*Bearing Failure had caused severe damage to the shaft stopping the loading of trains and the ability to meet customer deadlines potentially costing the quarry hundreds of thousands of pounds in lost revenue. Traditional repair method of complete drum replacement would require the removal of the building's roof and some of the structural frame which houses the conveyor, hire of a crane & manufacture of a new roller and rubber lagging which could take over five days to complete, this was no acceptable to the quarry or their customers.*

\* Severe damage to conveyor roller drive shaft View of the tight application area Former fabricated on site to create new bearing mounting surface Shaft repair being carried out insitu without the need to remove anything from the conveyor ,

The repair was carried out in accordance with Belzona System Leaflet MPT-2 For rebuilding damaged shafts using forming techniques

The application was carried out and the conveyor back into service the following day ensuring that they made their customers deadline. Cost of conveyor being out of service £10,000.00 per hour Traditional repair method materials costs - Crane hire and rubber lagged new drum £3,000.00 Traditional repair method lost time - five days of lost conveyor based on 12 hour shifts =
