CORROSION PROTECTION OF DISTRICT HEATING PIPEWORK WITH BELZONA

Customer Location: District heating company, Sweden

Application Date: June 2013

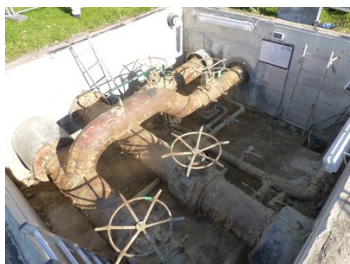
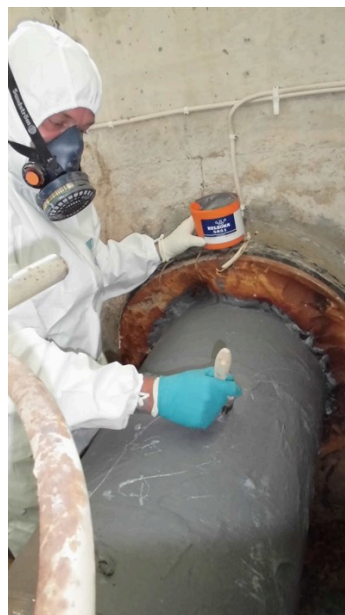
Photograph Descriptions

Corrosion under insulation and on the pipes, valves and other naked steel parts, due to water penetrating into the chamber.

* 1. General view of corroded pipework in the access chamber 2 Blasting, with dry ice 3. Coating the hot feedpipe with Belzona 5851 4. Completed work, with Belzona on all exposed steel parts ,

Application carried out in accordance with a modified version of Belzona System Leaflet VPF-2. Blasting, with dry ice (Carbon Dioxide) used to remove corrosion. Coating of all metal parts carried out using; Belzona 5831 on cold parts, Belzona 5841 on the return water pipe and Belzona 5851 on the feed water pipe.
