# BELZONA SEALS CORRODED SEWAGE PIPE AT BUSY POLICE HEADQUARTERS

ID: 4678

**Customer Location:** Police Headquarters, Bedfordshire UK  
**Application Date:** March 2013

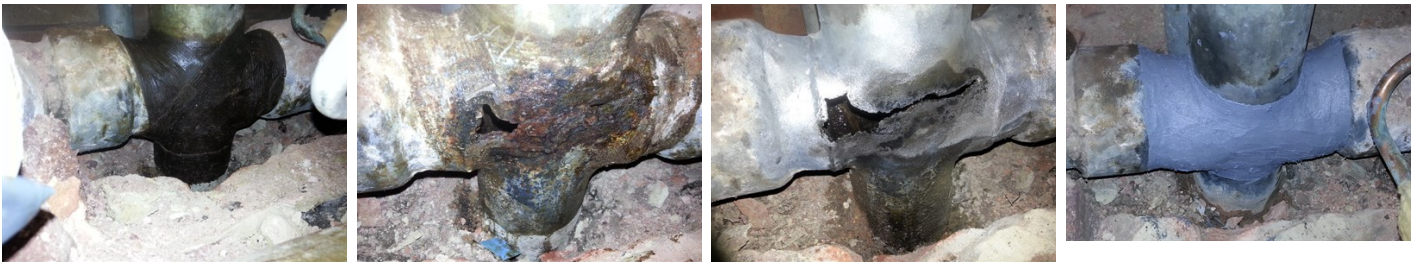
- \* Corroded pipe wrapped with adhesive tape ,
- \* Adhesive tape removed showing corroded hole and crack ,
- \* Corroded area after cleaning and then abrading with MBX Bristle Blaster ,
- \* Completed repair ,

A 4" cast iron sewage pipe behind toilets on the 3rd floor started leaking at the point where 4 x pipes connect, causing water damage to the toilet blocks on both floor levels below.

Application was carried out in accordance with Belzona Know How System Leaflet VPF-11. After removing the adhesive tape installed by the customer, the corroded and leaking area was cleaned down and then abraded using MBX Bristle Blaster to create a profile, which created a larger hole. This enlarged hole was gradually filled with Belzona 1291 until sealed and then wrapped over with Belzona 1161 incorporating Belzona 9341 (Reinforcing Tape).
