BELZONA SEALS CORRODED SEWAGE PIPE AT BUSY POLICE HEADQUARTERS

ID: 4678

Customer Location: Police Headquarters, Bedfordshire UK
Application Date: March 2013

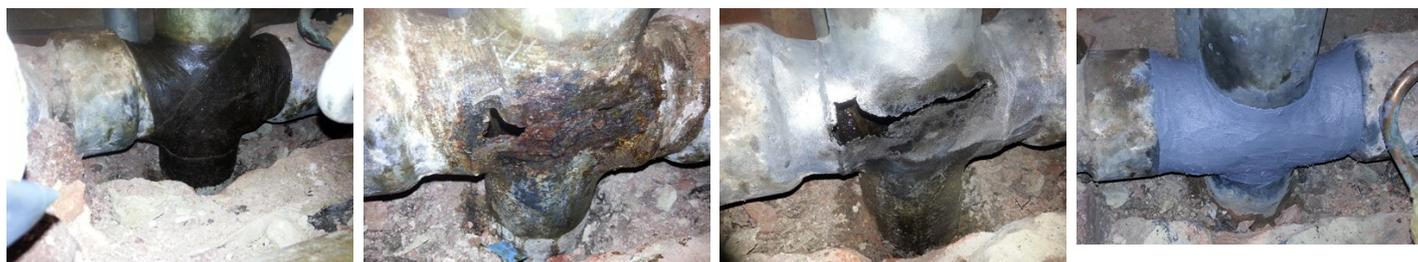
Photograph Descriptions

The customer had tried to cure the leak by wrapping a type of adhesive tape around the corroded area. When this failed they contacted Belzona for a fast, cost effective, permanent and quiet solution.

- * Corroded pipe wrapped with adhesive tape ,
- * Adhesive tape removed showing corroded hole and crack ,
- * Corroded area after cleaning and then abrading with MBX Bristle Blaster ,
- * Completed repair ,

A 4" cast iron sewage pipe behind toilets on the 3rd floor started leaking at the point where 4 x pipes connect, causing water damage to the toilet blocks on both floor levels below.

Application was carried out in accordance with Belzona Know How System Leaflet VPF-11. After removing the adhesive tape installed by the customer, the corroded and leaking area was cleaned down and then abraded using MBX Bristle Blaster to create a profile, which created a larger hole. This enlarged hole was gradually filled with Belzona 1291 until sealed and then wrapped over with Belzona 1161 incorporating Belzona 9341 (Reinforcing Tape).
