BELZONA REPLACES MECHANICAL MOVEMENT JOINTS

ID: 4679

Customer Location: Hospital, Newcastle Upon Tyne, UK
Application Date: September, 2013

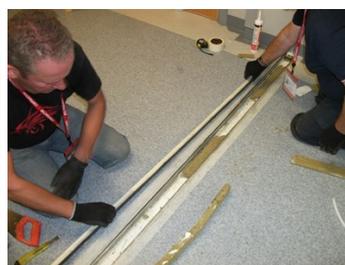
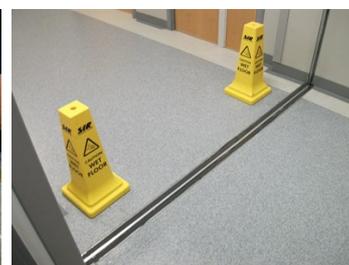
Photograph Descriptions

The new building was built approx. 3 years ago and mechanical movement joints were installed throughout the building. Over the 3 year period there has been a lot of movement within the building resulting in the gap on the joints increasing to the extent that they are now failing and allowing cleaning detergents to by-pass the sealing "O" Rings on the joints and to leak into the rooms below, some of which are operating theatres.

- * Diagram of the original mechanical joint ,
- * Sliding components of expansion joint removed ,
- * Aluminium spacer bar being fitted in centre of the joint ,
- * Finished expansion joint ,

Application was carried out in accordance with Belzona System leaflet FPA-6. The existing sliding components of the joint were removed from the fixed shoulder of the joint. These were prepared using the MBX Bristle Blaster. The 2 edges of an aluminium spacer bar (19mm W x 38mm H) were also prepared. After centering the spacer bar the Belzona 2221 system was applied to either

side of the spacer bar to create a sealed expansion joint.
