# Transformer bushing leak sealed with Belzona

ID: 4682

Customer Location: Glasgow, Scotland  
Application Date: September 2013

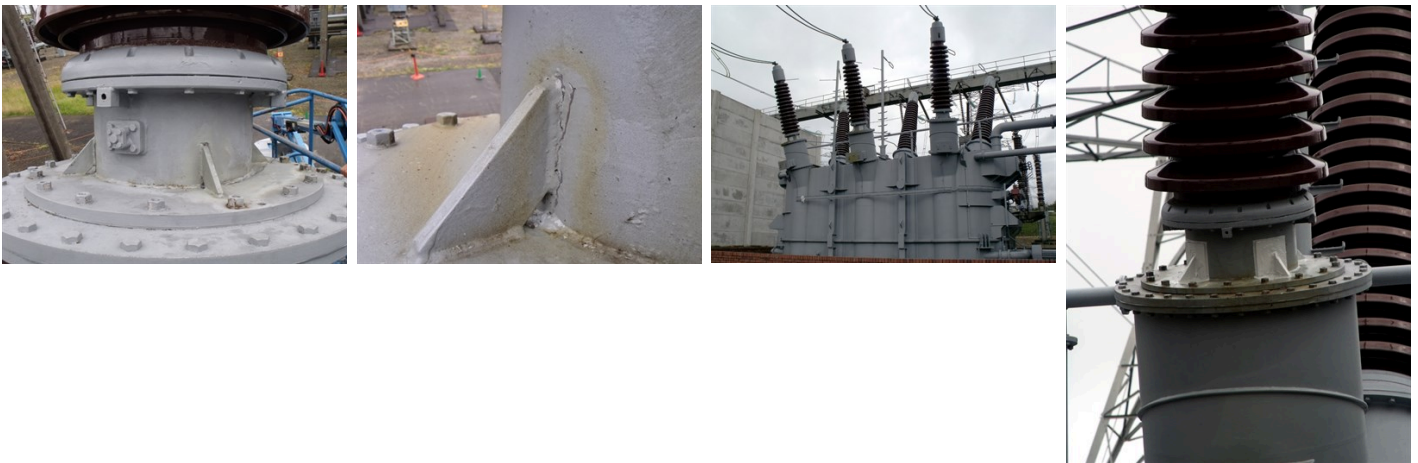
- \* 1. Bushing before. ,
- \* 2. Struts before application showing crack. ,
- \* 3. Transformer after overcoating with Belzona 5831 ,
- \* 4. Plate bond after overcoating with Belzona 5831 ,

Two 19 inch diameter bushings on a transformer were leaking oil. The leaks were coming from cracks in four steel support struts.

The repair was carried out in accordance with an adapted version of Belzona system Leaflet SOS\_1. The leaks were first stemmed using Belzona 9611. Pre blasted plates were then bonded into place around the struts using Belzona 1161, the purpose of these plates was to give the structure back some strength so the cracks in the steel would not propagate. The repairs were then protected with Belzona 5831.
