Belzona Expands the Life of Expansion Joint

ID: 4684

Customer Location: On-shore GOSP, KSA
Application Date: 2013

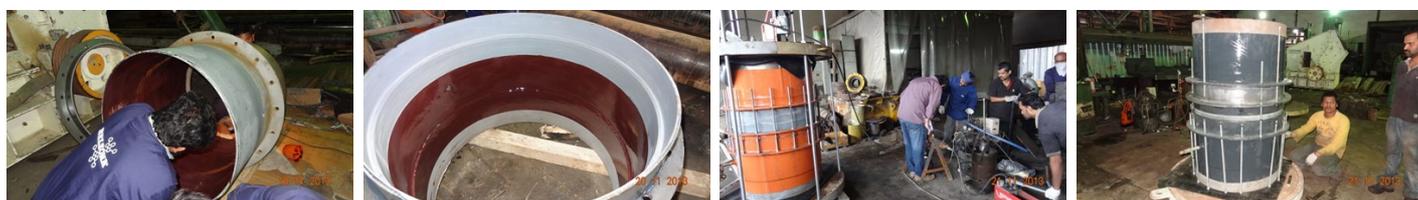
Photograph Descriptions

During the start-up, the 34inch expansion joints in the flare header started leaking forcing the plant to shut down under this emergency situation.

- * Lining in action ,
- * Lining completed ,
- * Expansion joint application ,
- * Application finished ,

The application was carried out in accordance with modified Belzona Know-How System Leaflet MPT-06. Rebuilding and machining of sealing faces was carried out with Belzona 4301. Internal coating/non sealing faces were coated with Belzona 4311.

All six expansion joints were tested for "Zero leakage" and installed back to the flare header. The expansion joints are working fine to date, without any leaks.
