# CLARIFIER TROUGHS RESTORED WITH BELZONA

ID: 4685

Customer Location: Water treatment facility, Roseville, California

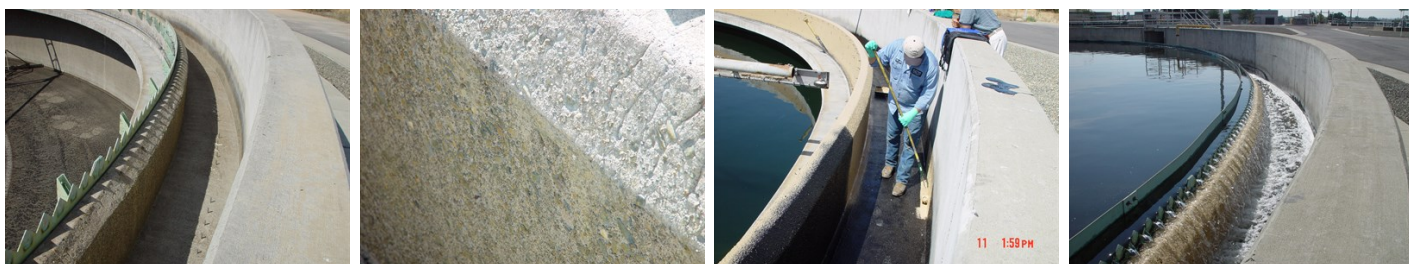
Concrete clarifier troughs had deteriorated to point of exposing the aggregate in the concrete.

- \* Clarifier trough before application - overview ,
- \* Clarifier trough before application - detail ,
- \* Belzona® 5811 application ,
- \* Clarifier trough In operation after coating ,

Application was carried out in accordance with Belzona Know-How system Leaflet TCC-15.

Belzona® 5811 coating eliminated need for costly replacement of concrete clarifier troughs. Based on the success of this application, customer not only applied Belzona to a second clarifier but also specified Belzona® 5811 for all immersed metals for their new and much larger additional wastewater facility.
