BELZONA MADE A QUICK AND EASY BELT REPAIR

ID: 4687

Industry: Water / Wastewater
Application: SHM-Solids Handling Machinery

Customer Location: Durham, New Hampshire, USA
Application Date: July 29, 2008

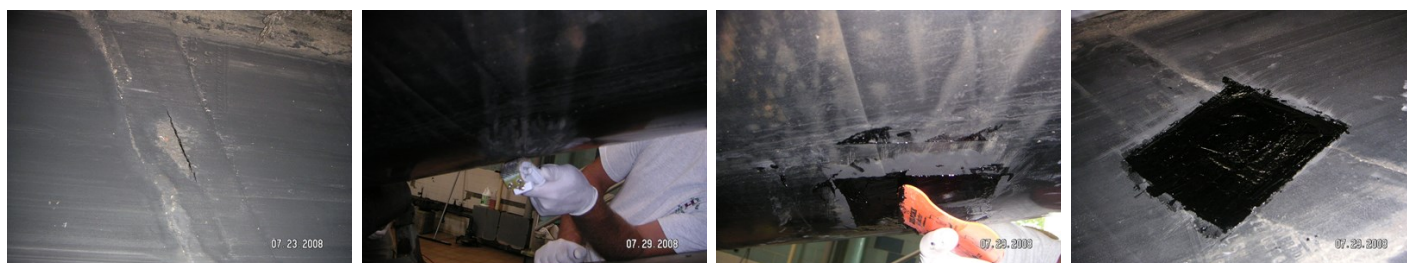
Photograph Descriptions

A tear in a conveyor belt carrying solid waste threatened to shut down this section of the plant. The belt has previously been repaired by hot vulcanizing, which did not provide a long term solution.

- * Tear in belt. ,
- * Surface preparation. ,
- * Application of Belzona 2311. ,
- * Completed application. ,

The belt was degreased with Belzona 9111. The belt was roughened using the Belzona roughing brush, top and bottom. Belzona 2911 was applied to the roughened areas and allowed to cure. Belzona 2311 was applied to the damaged areas. The application was carried out in accordance with a modified version of Belzona Know-How System Leaflet SHM-1.

The repair was completed in less than two hours and at a fraction of the cost of belt replacement or hot vulcanizing, thus

minimizing downtime. The repair is still in service.
