# BELZONA MADE A QUICK AND EASY BELT REPAIR

ID: 4687

Industry: Water / Wastewater  
Application: SHM-Solids Handling Machinery

Customer Location: Durham, New Hampshire, USA  
Application Date: July 29, 2008

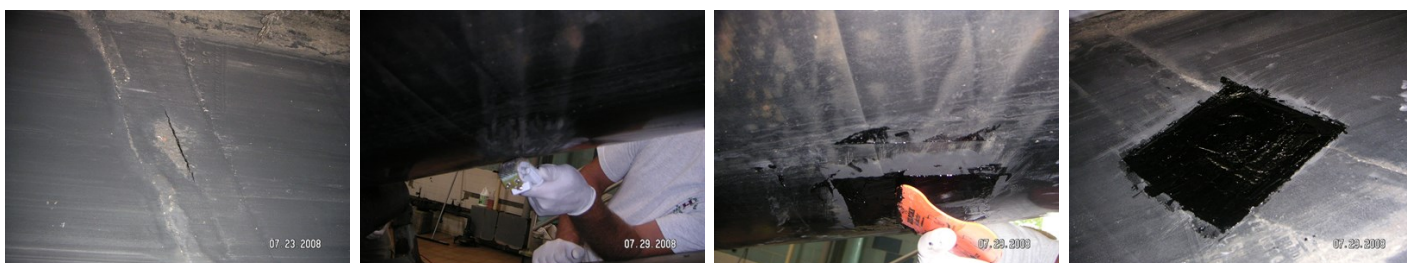
A tear in a conveyor belt carrying solid waste threatened to shut down this section of the plant. The belt has previously been repaired by hot vulcanizing, which did not provide a long term solution.

- \* Tear in belt. ,
- \* Surface preparation. ,
- \* Application of Belzona 2311. ,
- \* Completed application. ,

The belt was degreased with Belzona 9111. The belt was roughened using the Belzona roughing brush, top and bottom. Belzona 2911 was applied to the roughened areas and allowed to cure. Belzona 2311 was applied to the damaged areas. The application was carried out in accordance with a modified version of Belzona Know-How System Leaflet SHM-1.
