# BELZONA PROTECTS WASTEWATER PUMP FROM EROSION-CORROSION

ID: 4688

Customer Location: Wastewater Plant, Niagara Region,  
Ontario, Canada

Application: CEP-Centrifugal Pumps

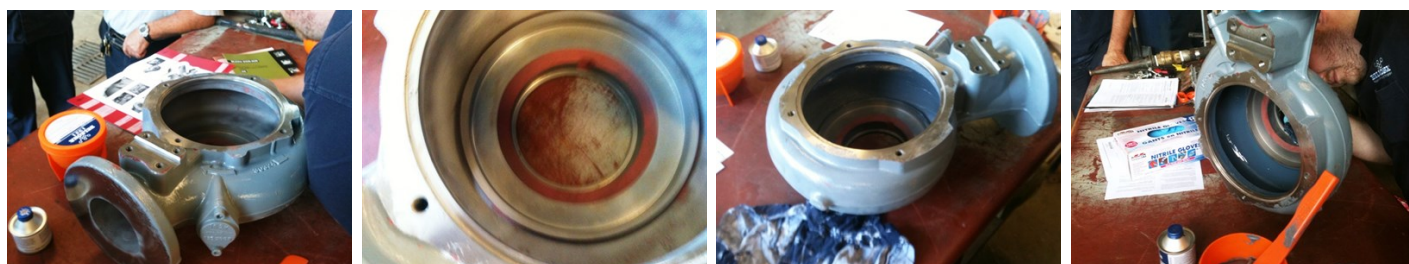
## Photograph Descriptions

High levels of erosion-corrosion caused by entrained solids in wastewater media being pumped for processing.

- \* View of new cast steel pump volute ,
- \* Prepared surface by abrasive blasting ,
- \* First coat of Belzona 1321 (Grey) applied ,
- \* Second coat of Belzona 1321 (Blue) applied ,

Application was carried out by brush in accordance with Belzona Know-How System Leaflet CEP-03.
