BELZONA SEALS LIVE LEAK IN LARGE WATER TANK

ID: 4690

Application: TCC-Tanks and Chemical Containment Areas

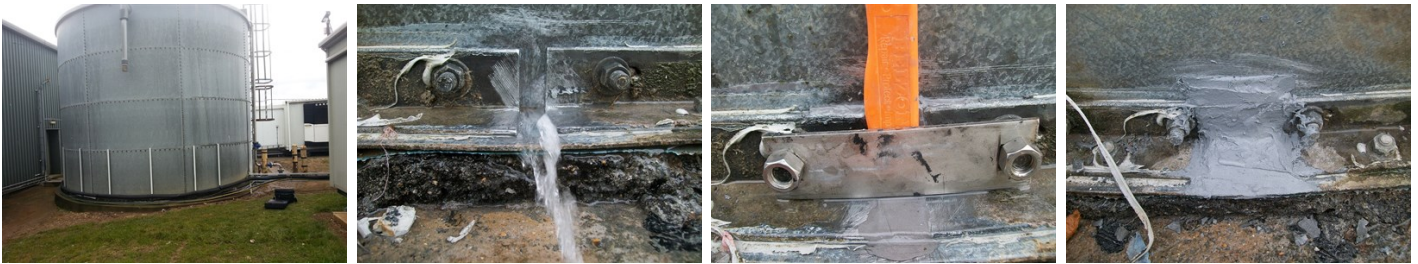
Photograph Descriptions

The tank was leaking at the base due to a failed seal, causing local flooding. The customer had tried to seal the leaking area with other products but this had failed and was still leaking. So a local service company recommended they contact Belzona.

* 1. Large water tank with leaking area at base 2. Leaking area showing water squirting out 3. Leak stopped with Belzona 1291 using clamp to hold it in place against force of leaking water 4. Completed repair coated over with Belzona 1161 & 9341. ,

Application was carried out according to Belzona Know How System Leaflet TCC-1. After removing the previous repair materials and roughening the surface, belzona 1291 used in conjunction with a clamp was used to stem the leak before applying Belzona 1161 incorporating Belzona 9341 (reinforcement Tape) over the area to create a permanent seal.
