# BALCONIES WATERPROOFED WITH BELZONA

ID: 4691

Customer Location: Boutique Hotel, London  
Application Date: June 2013

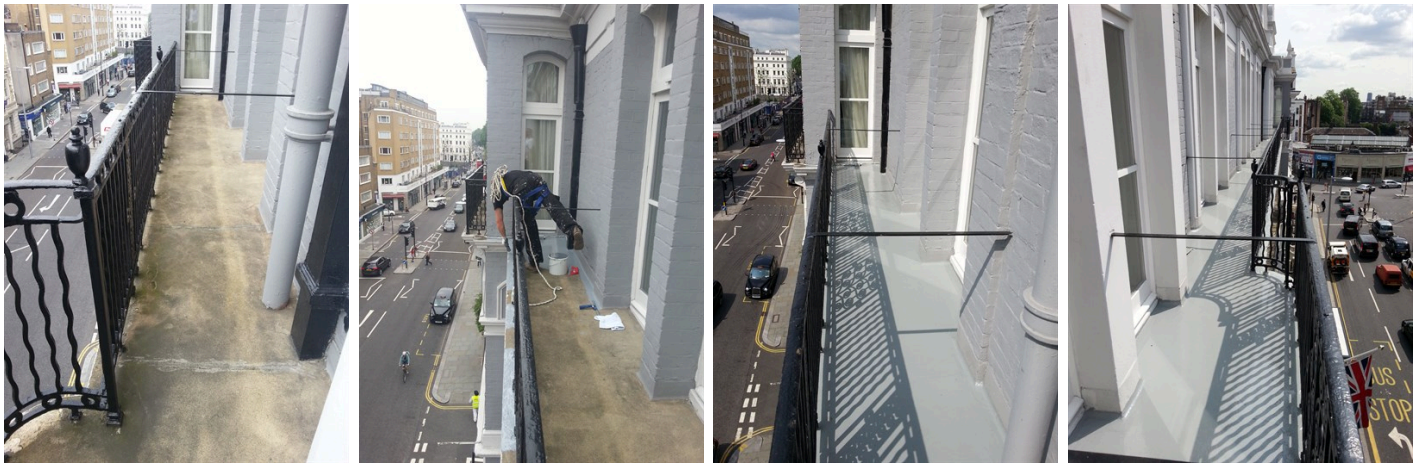
The aging balconies had numerous fine cracks and the hotel had been suffering from water penetration issues. With high occupancy rates a quick turnaround was essential.

- \* Unprotected balconies ,
- \* Contractor carrying out application ,
- \* & 4. Completed work ,

Application was carried out in accordance with a modified version of Belzona Know-How System Leaflet TCC-15. the Belzona 5811 was applied using brushes and squeegees.

Due to the products solvent free properties the contractor was able to complete the application very quickly and without any disruption to the hotel guests. The standard grey colour also complemented the existing colour scheme on the exterior of the hotel. As the balconies don't get used there was no need for a grip system.
