# BELZONA RESTORES BED ON A PRESS BRAKE

ID: 4693

LVD Pressbrake used to bend sheet metal

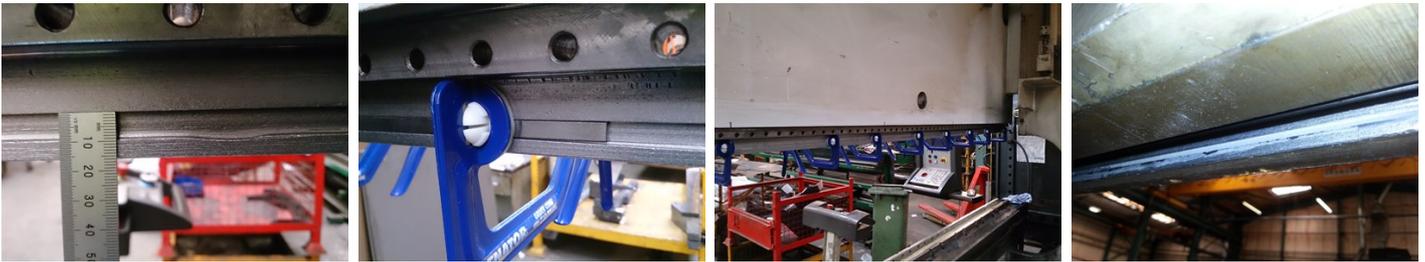
The locating bed on the press had worn over time due to sliding different shaping tools into place. This was leading to the shaping tools sitting at an angle and producing inaccurate results.

- \* Damaged area after surface preparation ,
- \* Area to be rebuilt ,
- \* Forming plates being held into place ,
- \* Completed application ,

Application was carried out in accordance with Belzona System Leaflet GSS-8. Forming boards were made and coated with Belzona 9411 (Release Agent). They were then held in place along the length of the press. Belzona 1121 was injected to the require depth. Once cured the formers were removed revealing the new surface.
