EFFLUENT CLARIFIER TANK REFURBISHED WITH BELZONA

Industry: Pulp & Paper

Concrete effluent tank

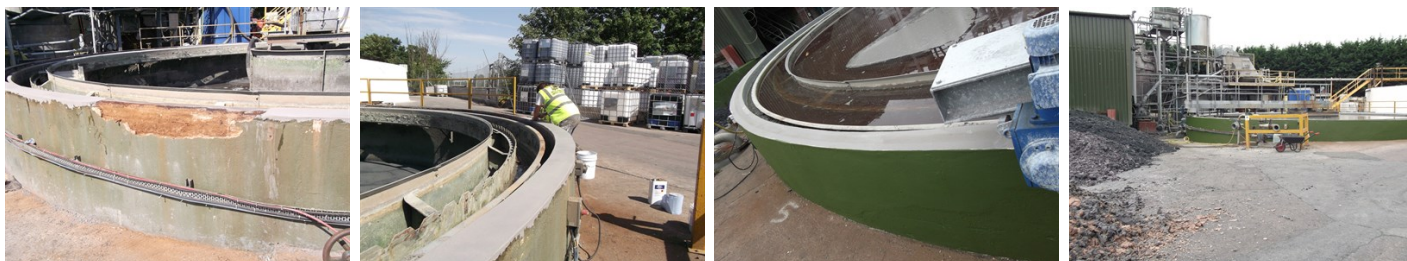
Photograph Descriptions

Breakdown of the concrete substrate due to water ingress and freeze thaw cycles had left the tank at risk of stoppages to production which the client could not afford. Traditional repairs or replacement would take too long and did not fit into the client's production schedule. The client only had a five day window which they could have the clarifier off line,

- * Area of damage to concrete substrate ,
- * Application of Belzona® 4131 ,
- * Close up of completed application ,
- * Completed application, *note customer painted the tanks outside after coating with Belzona® 5151 to match corporate colour scheme. ,

Application was carried out in accordance with Belzona Know-How System Leaflets FPA-1 & FPA-6

This Belzona solution was chosen as the Belzona 4131 needed minimal cure time meeting the clients demanding schedule. The Belzona 5811 & Belzona 5151 were applied to extend the life of this crucial site asset by stopping any further water ingress into the substrate.
