BELZONA SOLUTION FOR LEAKING BALCONY

ID: 4695

Customer Location: Church property, SW England
Application Date: Aug 2013

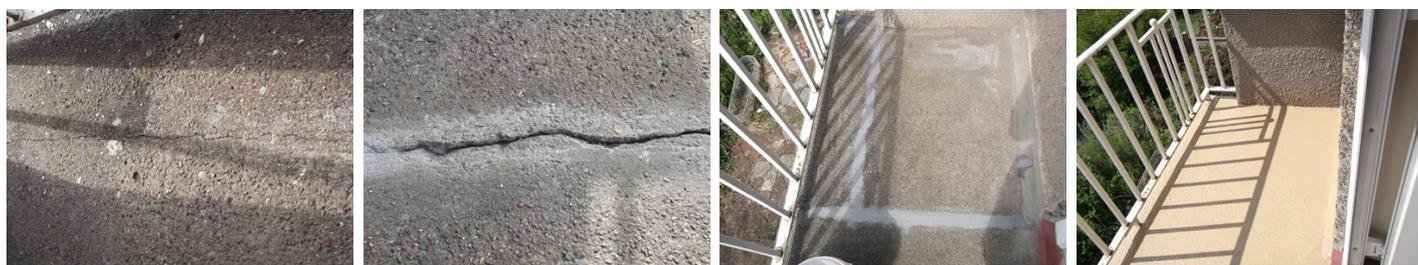
Photograph Descriptions

Over time the movement of the balcony had caused cracks in the substrate. The client had previously tried sand and cement repairs which had failed due to poor adhesion to the substrate. The client wanted a long term cost effective repair solution to these cracks and protection from future water ingress into the substrate.

- * Original condition of cracked balcony ,
- * Close up of crack after cleaning it out ,
- * Cracks repaired with Belzona 4131 ,
- * Completed application coated with Belzona 5811 ,

Application was carried out following modified Belzona System leaflets FPA-1 & TCC-15

After previous traditional sand and cement repairs had failed the Belzona 4131 was selected due its outstanding adhesion and the ability to feather the repairs edges. The Belzona 5811 coating solution was chosen for the long term water-proofing and aesthetic appearance of the finished application.
