BELZONA PROVIDES HYGEINE SOLUTION FOR SWEET FACTORY

ID: 4696

Customer Location: Sweet manufacturer, Leeds, UK
Application Date: June 2013

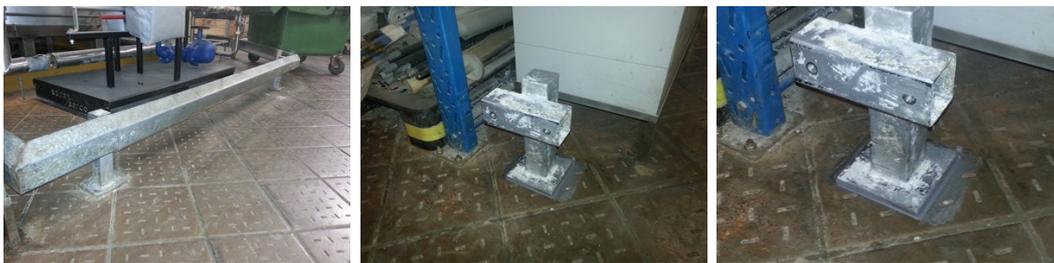
Photograph Descriptions

* 1. Typical crash barrier assembly 2 . Crash barrier base bonded to steel tile 3. Close up after cure ,

Application was carried out using a modified version of Belzona System Leaflet FPA-11. Both the steel tiles on the floor and steel base of the crash barriers were prepared using an MBX Bristle Blaster before being bonded together using Belzona 1111. Care was taken to ensure Belzona 1111 exuded from all edges and was used to create a smooth fillet around the base.

Belzona was selected for its high bond strength which was tested by the client to the point where, when a lateral force was applied, it resulted in the tile being forced up from the concrete it was fixed into. The bond between crash barrier base and steel tile remained intact. In addition to this, it met the criteria for hygiene requirements.
