BELZONA ALLOWS HOUSTON CLARIFIER TO BE CLEAR AGAIN

Industry: Water / Wastewater
Application: TCC-Tanks and Chemical Containment Areas
Substrate: Concrete
Products: * Belzona 4131 (Magma-Screed) ,
* Belzona 5811 (Immersion Grade) ,

Customer Location: Houston, TX, USA
Application Date: September 2013

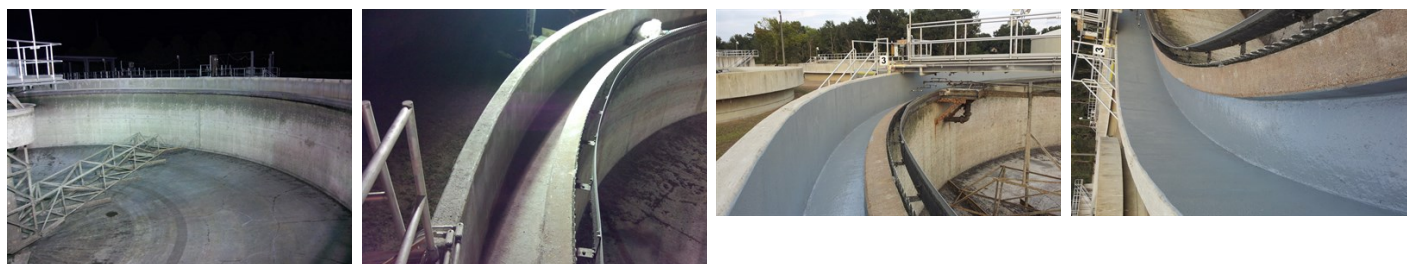
Photograph Descriptions

With damaged concrete and no coating, the trough was hard to keep clean, taking 2-3 times longer than when new.

- * Overall view of clarifier ,
- * After rebuilding with Belzona 4131 ,
- * Completed project ,
- * Completion application ,

The customer was looking for a long-term repair in lieu of repairing it every 2-3 years as they have done in the past. With experience in other areas of the facility, the customer felt confident Belzona could do just that.

The application was carried out in accordance with Belzona Know-How System Leaflet TCC-9.

The Belzona repair was able to be carried out over a long weekend at the facility in comparison to the competition taking them down for over a week, Belzona was chosen not only for the quick turn-around but also for a proven track record at the facility on other repairs. The facility saved time and money.
