# BELZONA KEEPS NATURAL GAS LINE GOING

Industry: Oil & Gas  
Application: VPF-Valves, Pipes and Fittings  
Substrate: Carbon Steel  
Products: \* Belzona 5811 (Immersion Grade) ,  
\* Belzona 4151 (Magma-Quartz Resin) ,  
\* Belzona 5111 (Ceramic Cladding) ,

Customer Location: Texas, USA  
Application Date: May 2013

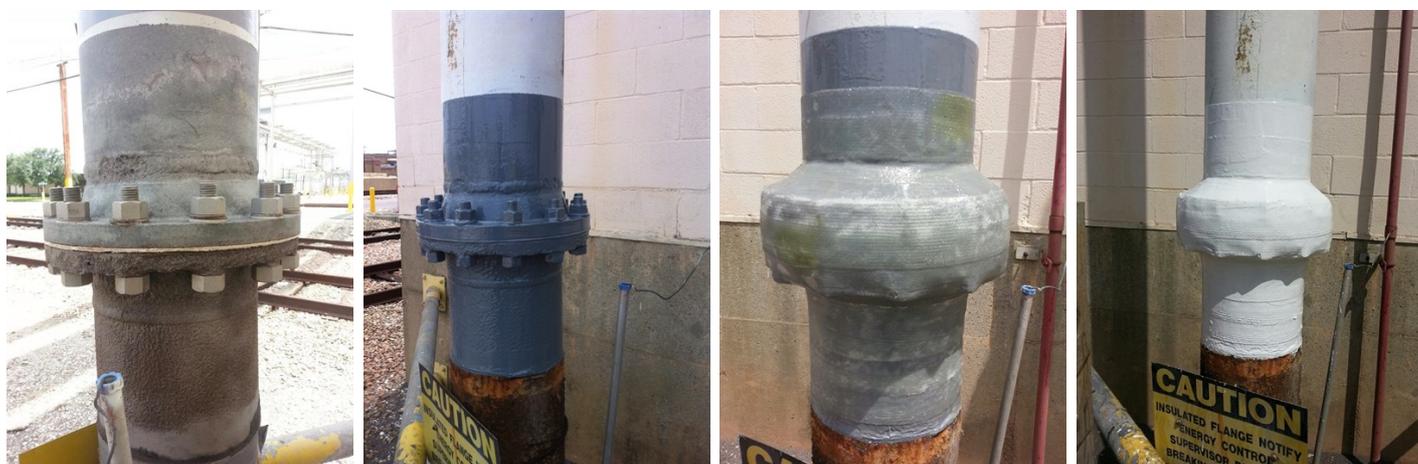
Upon customer inspection they found the pipe near the flange area becoming thin-wall and they also had concerns about corrosion on the flange. This is the natural gas line to the plant and they could not go down for the repair without the plant going down also.

- \* After blasting to prep. ,
- \* Belzona 5811 applied to protect. ,
- \* Resin wrap applied. ,
- \* Top coat for protection. ,

Unit was blasted using sponge media for non-spark preparation. Belzona 5811 was then applied to protect against CUI, then a resin wrap was applied to give strength back to the line. A top coat of Belzona 5111 was applied for further protection.
