# COOLING WATER PIPE REBUILT AND PROTECTED WITH BELZONA

ID: 4706

Application: VPF-Valves, Pipes and Fittings

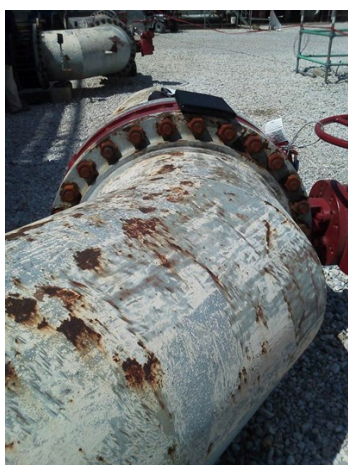
- \* Before application. ,
- \* Through-holes and pitting filled. ,
- \* Completed application. ,

Splash and spill from the nearby cooling tower caused severe pitting on the top portion of the cooling water pipes. Pipes were so thin that leaks were springing up weekly.

The application was carried out with a modified version of Belzona Know-How System Leaflet VPF-1.
