COOLING WATER PIPE REBUILT AND PROTECTED WITH BELZONA

ID: 4706

Application: VPF-Valves, Pipes and Fittings

Customer Location: Orange, TX

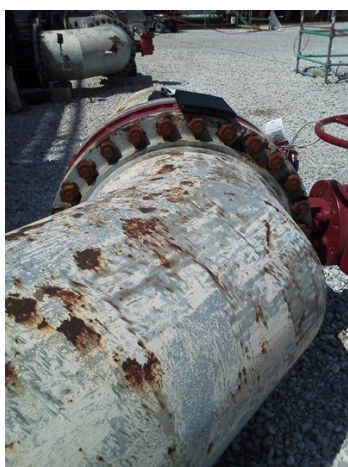
Photograph Descriptions

- * Before application. ,
- * Through-holes and pitting filled. ,
- * Completed application. ,

Splash and spill from the nearby cooling tower caused severe pitting on the top portion of the cooling water pipes. Pipes were so thin that leaks were springing up weekly.

The customer had a short outage where the cooling pipes had to be repaired or replaced. Repairing with Belzona gave the customer a quick turnaround and was much more economical.

The application was carried out with a modified version of Belzona Know-How System Leaflet VPF-1.
