BELZONA PROTECTS WALLS AND FLOORS AT CIDER PLANT

ID: 4707

Customer Location: Cider producer, Herefordshire, UK
Application Date: December 2012

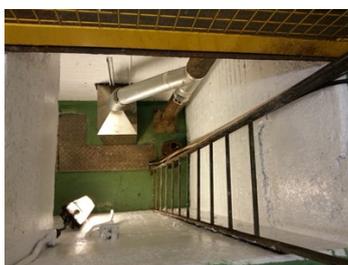
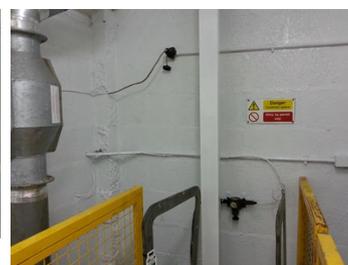
- * View into pit before application ,
- * pit after application ,
- * walls before application ,
- * walls after application ,

A very damp and dirty pit area.

Application was carried out in accordance with Belzona Know-How System Leaflets WPA-2, FPA-1 and FPA-8. The damaged areas of the floor were rebuilt using the Belzona® 4131 before coating with Belzona® 5231. Belzona® 5111 system was applied to the walls.
